**ALABAMA HAZARDOUS WASTES MANAGEMENT AND MINIMIZATION ACT
(AHWMMA)**

Compliance Evaluation Inspection (CEI) Report

Hyundai Sungwoo Auto USA Corporation
6177 Perimeter Parkway
Montgomery, Montgomery County, Alabama 36116

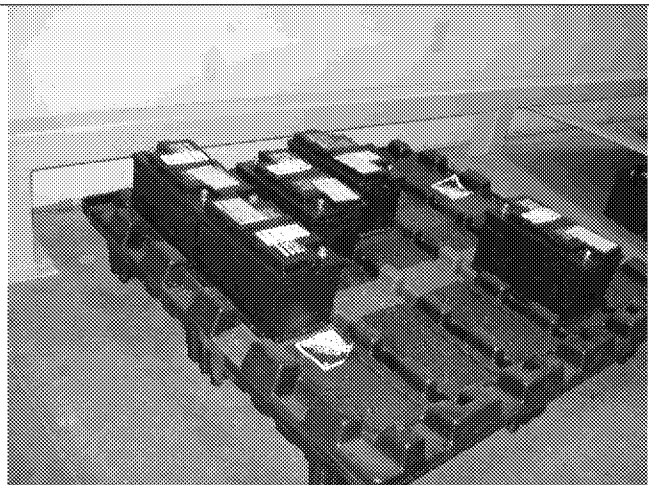
the pallets are built up three layers high. Mr. Lee told us that completed pallets are shrink wrapped. The JCI batteries are staged on pallets, but are placed in lined fiberboard shipping containers prior to shipment off-site.

3. Scrap JCI Batteries

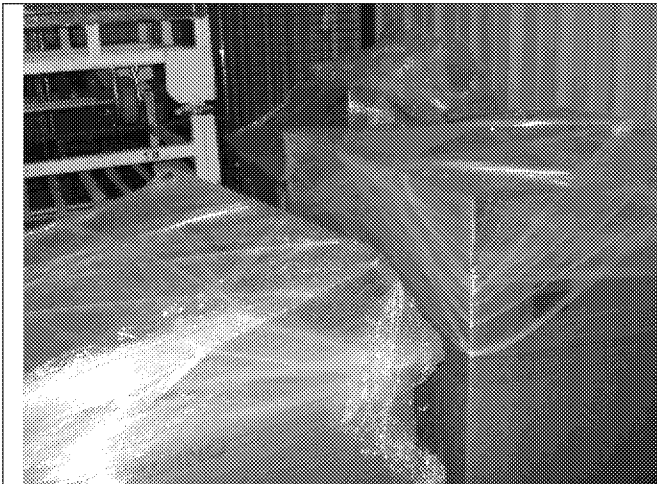
4. Boxes for intact JCI batteries

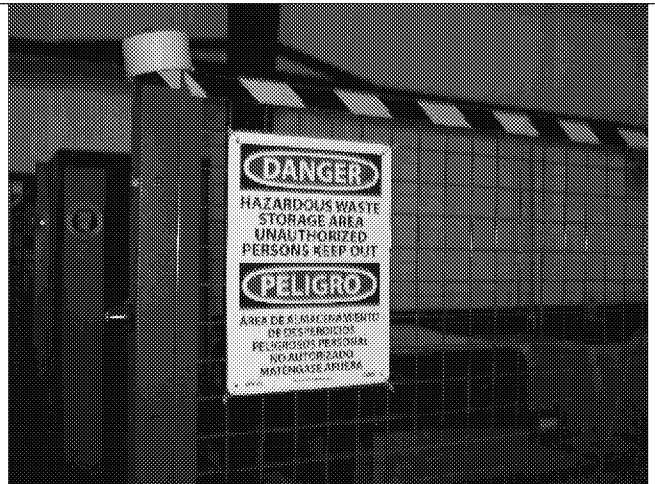
The Hazardous Waste Storage Area is a fenced enclosure located in the Charging Room in front of the charging table. Batteries that have cracked casings or that will not take or hold a charge are brought to this area, where they can be disassembled and drained of acid. The acid is collected in 15-gallon close-top plastic drums and sold to Eagle Battery for continued use. The disassembled carcasses are placed in fiberboard boxes with heavy plastic liners.

5. Hazardous Waste Storage Area

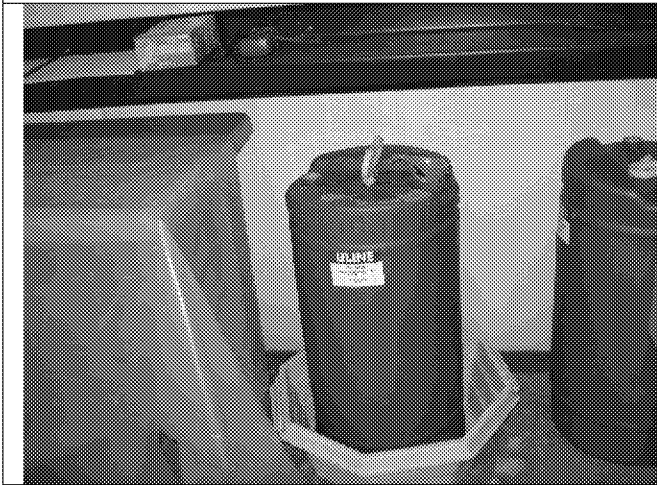
The drum of battery acid was not closed – the bung was open and a pouring funnel was in place, but no material was being added or removed. The lined fiberboard box was empty. See Photograph #5 through Photograph #7.

- One container of drained battery acid was not closed or marked.
- No hazardous waste profiles, manifests, or land disposal restrictions one-time notification/certification were available for review.
- The facility was unable to furnish any evidence proving that it had conducted weekly inspections of the hazardous waste storage area.
- The facility does not have a training program and has not provided hazardous waste training to any of its employees.
- The facility's contingency plan did not include home addresses.
- The facility did not maintain documentation demonstrating attempts to make arrangements with local authorities to familiarize them with the facility.

6. Drained battery acid
